FlexPay™ IV (with Omnia V06.00) Programming and Service Manual Insite360™ Forecourt with Applause® Media System

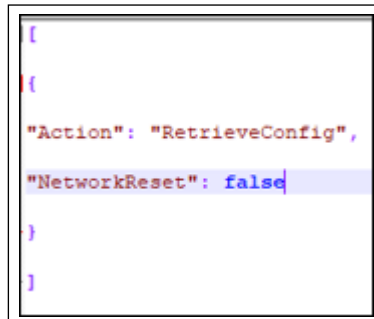
Figure 6-9: Omnia Configuration Retrieval - NO Network

- 1 Open **OmniaOp.json** file with a Text Editor (e.g. Notepad++).
- 2 Enter the information as shown in the following figure:

```
{
{
  "Action": "RetrieveConfig",
  "NetworkReset": false
}
}
```

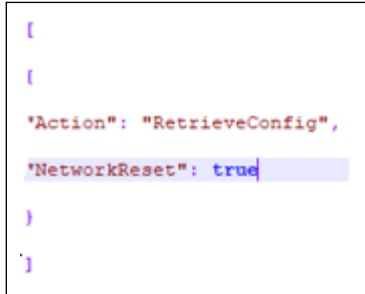
Figure 6-10: Omnia Configuration Retrieval - YES Network

- 1 Open the **OmniaOp.json** file with a Text Editor (e.g. Notepad++).
- 2 Enter the information as shown in the following figure.

```
[
{
  'Action': "RetrieveConfig",
  'NetworkReset': true
}
```
